MULTICOM
RESOURCES

SAINT ELMO MINE

ANNUAL AIR QUALITY MONITORING REPORT

1 April 2023– 31 December 2024

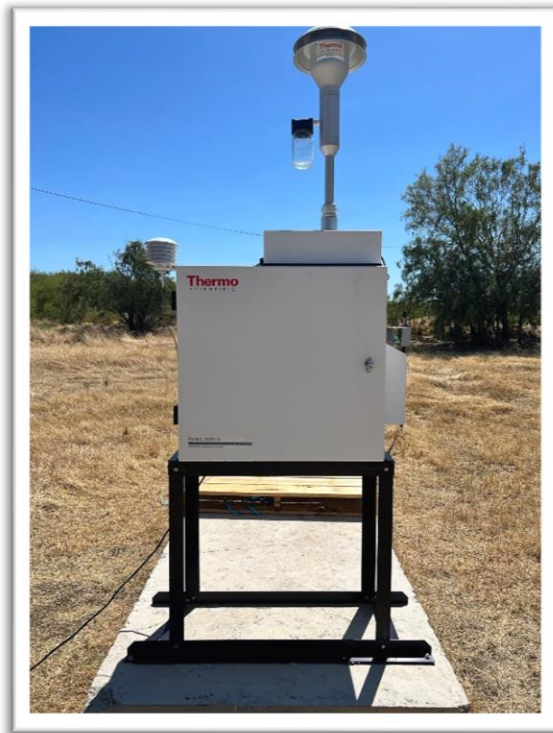
Figure 1 - Partisol 2500i Dichotomous Sequential Air Sampler

1. **Partisol 2500i Dichotomous Sequential Air Sampler (Partisol)**
 - Parameters Monitored: PM10, Vanadium & PM2.5.
 - Sampling Frequency: Continuous sampling.
2. **HIVOL 3000 High Volume Air Sampler (HIVOL)**
 - Parameters Monitored: Total Suspended Particulates (TSP).
 - Sampling Frequency: Samples taken every 6 days.
3. **Radiello Diffusive Sampler (Radiello)**
 - Parameters Monitored: Sulphur Dioxide (SO₂).
 - Sampling Frequency: Continuous passive sampling.
4. **Dust Deposition Gauges (DDG)**
 - Parameters Monitored: Dust deposition.
 - Sampling Frequency: Continuous sampling.

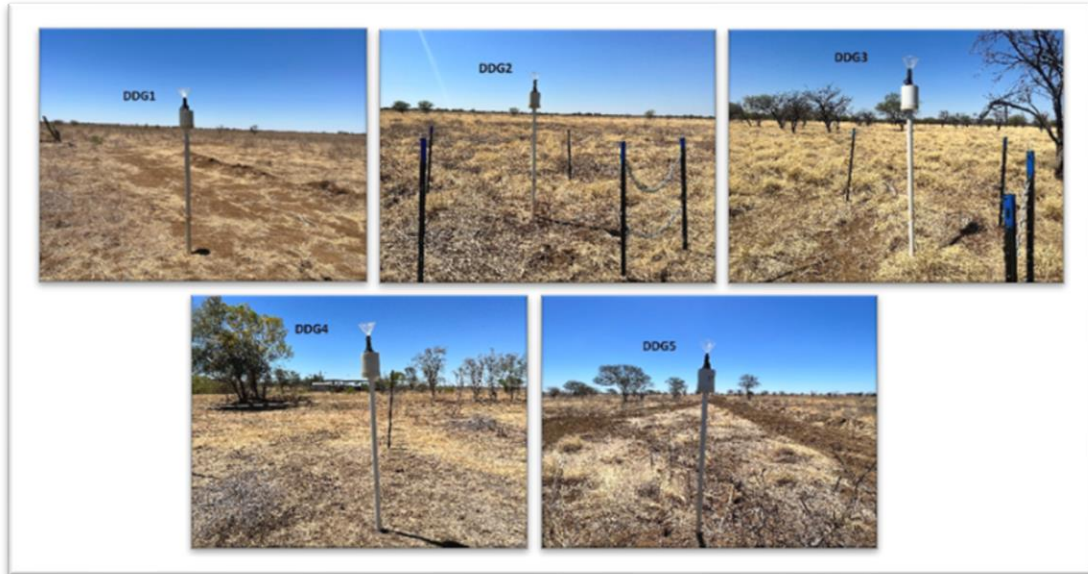
Figure 4 – Five Dust Deposition Gauges

A total of five Dust Deposition Gauges (DDGs) have been installed on the boundary of the mining lease to monitor dust deposition levels in accordance with the EA requirements, which stipulate that the annual average must not exceed $120\text{mg}/\text{m}^2$. The annual averages for all DDGs have been assessed (Error! Reference source not found.13) and while they generally comply with these conditions, one sample was found to exceed the limit and significantly affect annual averages. An individual sample from DDG2 in 2024, recorded an abnormally high-level of $1100\text{ mg}/\text{m}^2/\text{day}$ over 23 days; however, this sample is considered invalid as the gauge was knocked over by cattle and filled with soil (**Figure 1414**). Upon disregarding this erroneous sample, the revised annual average for DDG2 is calculated to be $70.4\text{ mg}/\text{m}^2$ (which previously was $140.65\text{ mg}/\text{m}^2$), which falls within the acceptable limits. Consequently, with the problematic data excluded, all DDGs are compliant with the EA's standards.

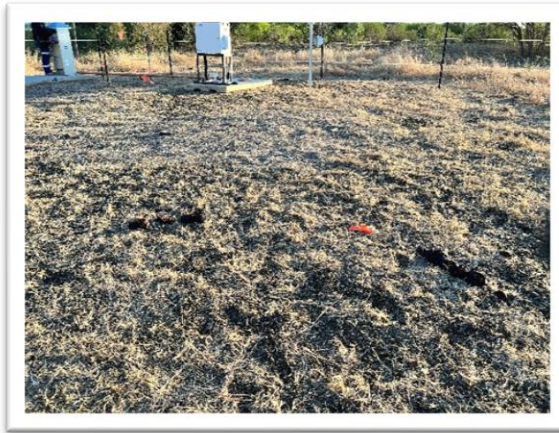
Limit PM10 50mg/m3/day Limit PM2.5 25mg/m3/day Limit Vanadium 1.1mg/m3/day					
Year	Parameter	Start Date	End Date	Value mg/m3/day	Explanation
2024	Vanadium	4/07/2024	5/07/2024	1.28	Possible cattle contamination
	PM2.5	24/09/2024	25/09/2024	27.20	Natural Environmental Conditions

Figure 7 – Cattle faeces and broken fencing observed within AQ area (July 2024).

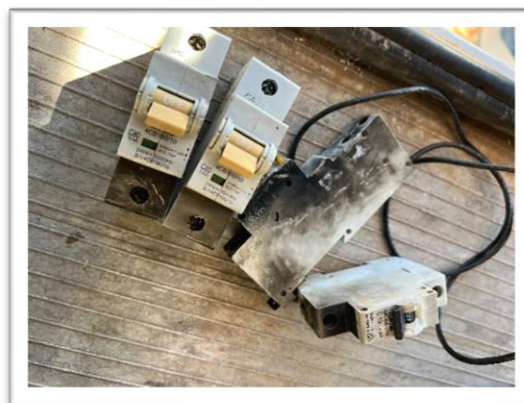
The remote location of the Saint Elmo Mine poses additional operational challenges. In October 2023, wildlife damage to above-ground wiring disrupted the power supply, requiring substantial upgrades to the homestead's electrical system. While data losses from filter jams or operational errors were infrequent, they caused minor gaps in the annual reporting periods. In some instances, replacement parts did not arrive in time, preventing continuous sampling. Power fluctuations due to weather conditions also impacted sampling continuity. Wildlife interference, including ants and native bush rats (*Rattus Villosissimus*), further worsened data gaps by obstructing tubes, restricting airflow, and damaging wiring, leading to electrical failures (**Figure 8 and 9**). In March 2024, an electrical failure required a technician to be flown in, but the issue couldn't be repaired onsite, and the machine was sent back for repairs, resulting in several weeks of missing data. The supplier could have provided a replacement, but it would have arrived just days before our machine was due back. Considering the cost and time required for staff to set up and return the machine, it was deemed not worth it. Additionally, in November and December 2024, a significant period of data loss occurred due to a pump malfunction, further exacerbated by delays in obtaining specialty replacement parts. The difficulty in sourcing specialized components and arranging repairs was compounded by a shortage of trained technicians in the area. The limited availability of resources has led to extended periods of machine decommissioning, contributing to data gaps and operational inefficiencies.

Figure 9 - Rat Damage to Saint Elmo Homestead Power Supply (July 2024).

19/07/2024	20/07/2024	Power Failure - Rats destroyed power
31/07/2024	1/08/2024	Power Failure - Rats destroyed power
31/07/2024	1/08/2024	Power Failure - Rats destroyed power
12/08/2024	13/08/2024	Power Failure - Rats destroyed power
18/08/2024	19/08/2024	Power Failure - Rats destroyed power
24/08/2024	25/08/2024	Power Failure - Rats destroyed power
17/10/2024	18/10/2024	Brittle and torn from heat - No analysis available
22/11/2024	23/11/2024	Hivol filters were lost in transit
28/11/2024	29/11/2024	Hivol filters were lost in transit
4/12/2024	5/12/2024	Hivol filters were lost in transit
10/12/2024	11/12/2024	Hivol filters were lost in transit

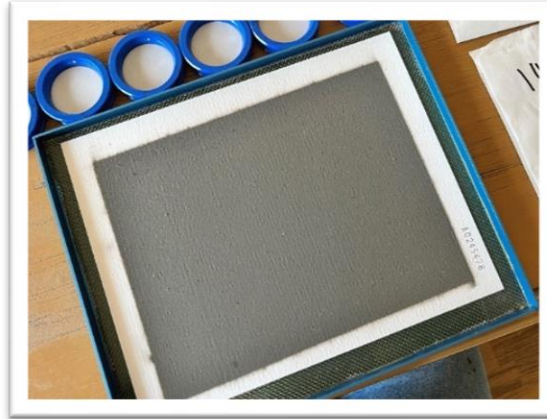
The Saint Elmo HIVOL data presents annual average TSP levels (**Table 8**). Monitoring is conducted every six days in accordance with the AQMP. The EA specifies that the annual average TSP concentration must not exceed 90 mg/m³. Data capture throughout the reporting periods was below 70%, primarily due to the remote location of the Saint Elmo Mine, which posed significant operational challenges. With no mining or construction activities taking place during this period, the TSP annual levels remained below the required limits. However, one monthly TSP limit was exceeded in November 2024, due to widespread bushfires across the region (**Table 9** and **Figure 10**).

TSP Limit 90mg/m3/day			
Start Date	End Date	Value mg/m3/day	Explanation
5/11/2024	6/11/2024	110.82	Bushfires during this period

Figure 10 - HIVOL exceedance following bushfire (November 2024).

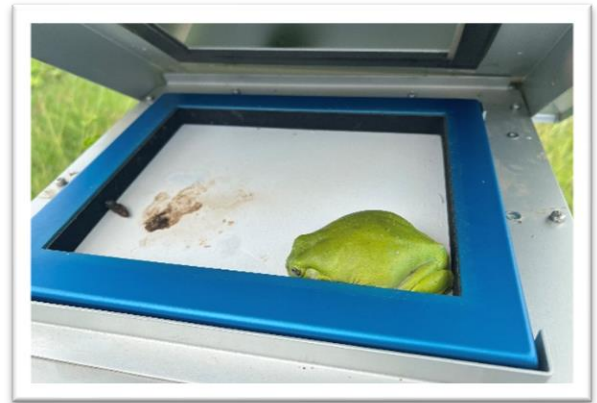
Figure 11 - Frogs Contaminated Samples

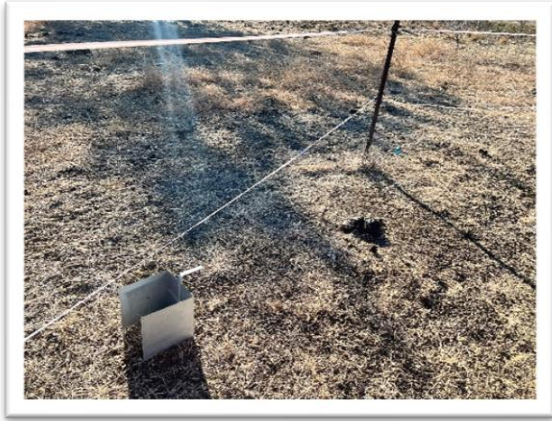
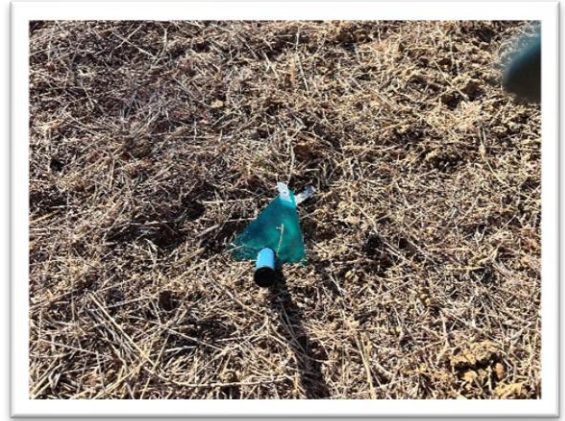
Start Date	End Date	Explanation
22/06/2023	21/07/2023	Damaged, not analysed. PN529
22/07/2023	21/08/2023	Damaged, not analysed. IZ598
20/02/2024	1/03/2024	No available filters- backorder a 5-6 week wait
2/03/2024	15/03/2024	No available filters- backorder a 5-6 week wait
16/03/2024	31/03/2024	No available filters- backorder a 5-6 week wait
1/04/2024	15/04/2024	No available filters- backorder a 5-6 week wait
6/08/2024	19/08/2024	Cattle in Paddock - Destroyed Sample

Figure 12 - Radiello Cattle Damage (August 2024)

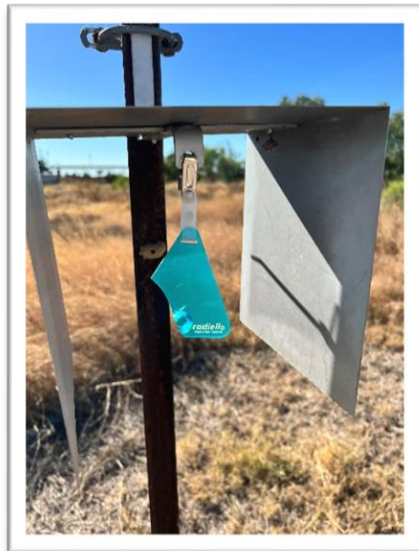
Figure 13 - Radiello Rat Damage (May 2024)

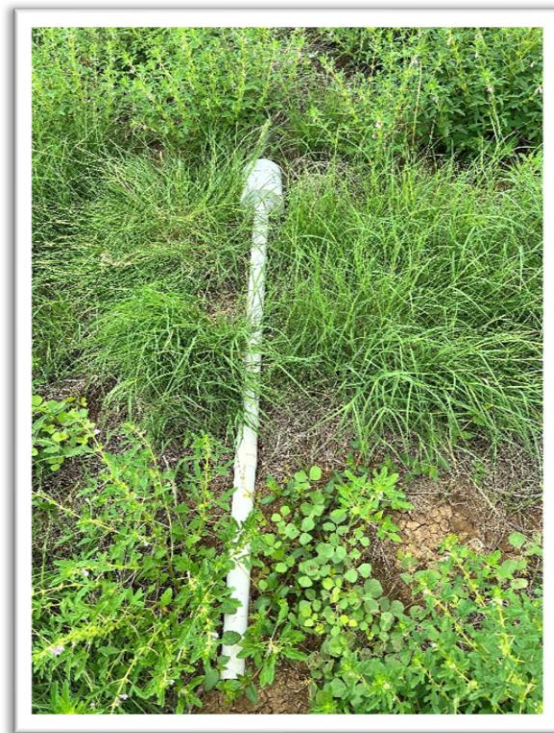
Figure 14 - DDG2 knocked over (15 April 2024)

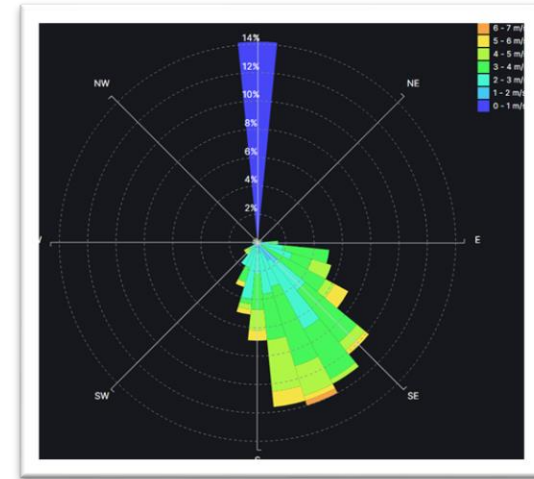
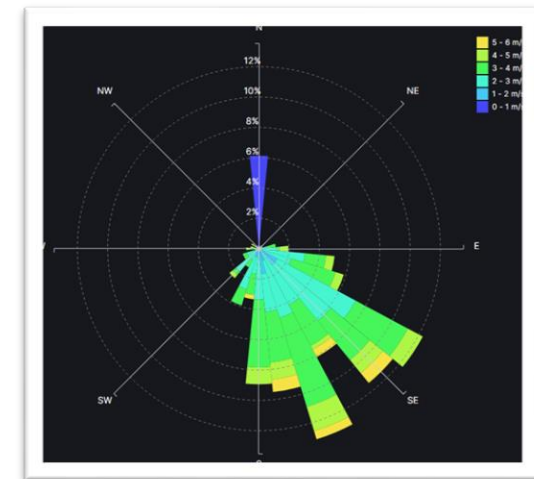
Wind patterns in Julia Creek are shaped by the local topography and weather systems. The town experiences dominant easterly to south easterly winds, which offer cooling relief during the summer months. However, wind speeds can fluctuate, and gusty conditions are often observed. Thunderstorms disperse pollutants, while lower wind speeds may result in pollutant accumulation. Wind direction can also transport pollutants from nearby sources, such as bushfires or dust from nearby mustering events. Wind speeds during the monitoring period ranged from 0 m/s to 7 m/s, with prevailing winds typically heading south or southeast (**Figure 21 & 22**).
