**MULTICOM
RESOURCES**

SAINT ELMO PROJECT

ANNUAL AIR QUALITY MONITORING REPORT

Reference: SEP-RPT-EV-00028

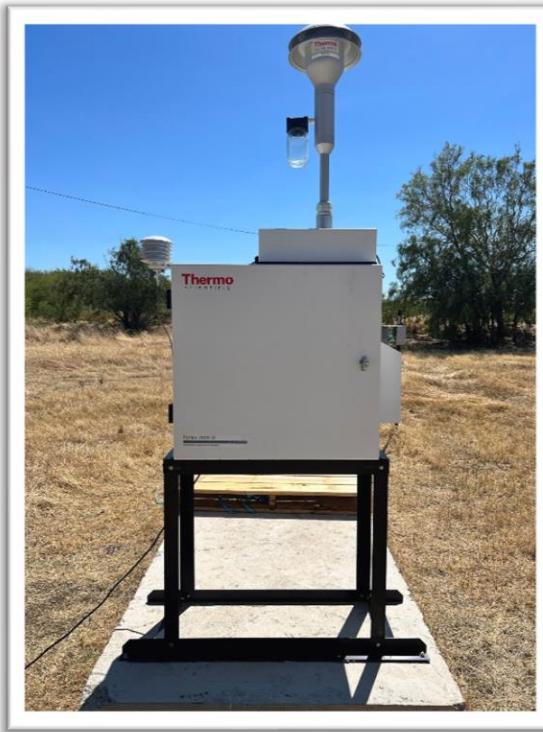
Figure 1 - Partisol 2500i Dichotomous Sequential Air Sampler

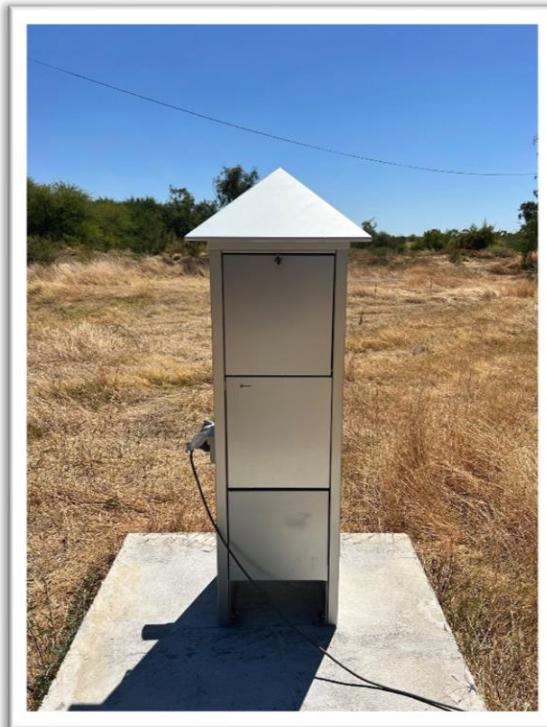
Figure 2 - HIVOL 3000 High Volume Air Sampler

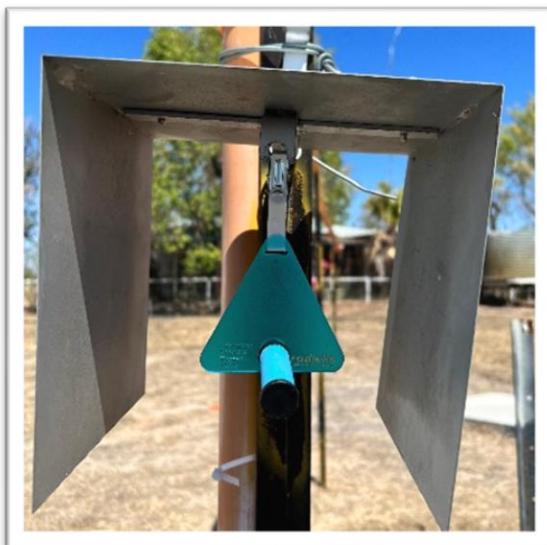
Figure 3 - Radiello Diffusive Sampler

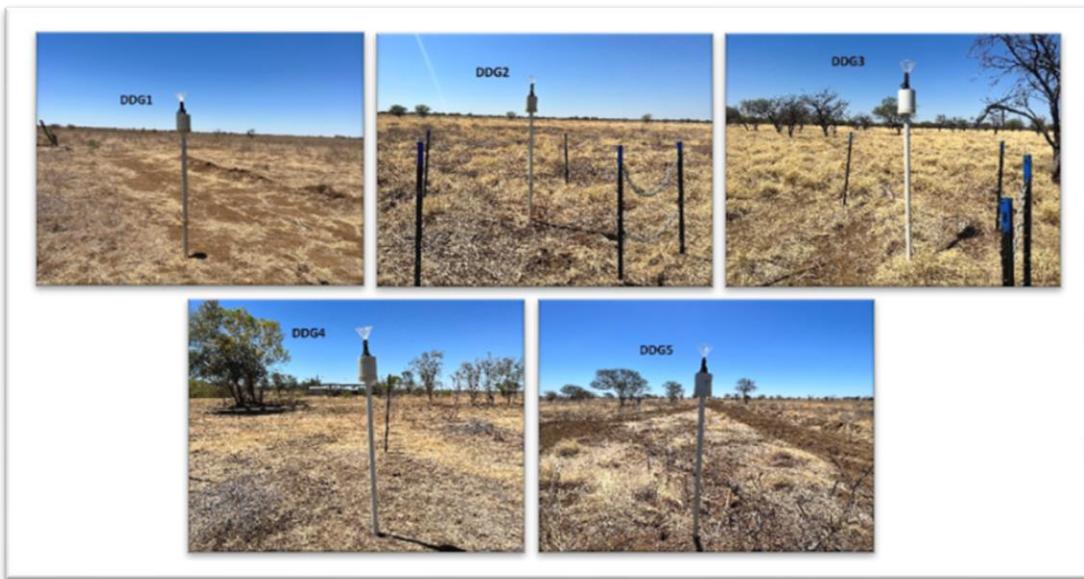
Figure 4 – Five Dust Deposition Gauges

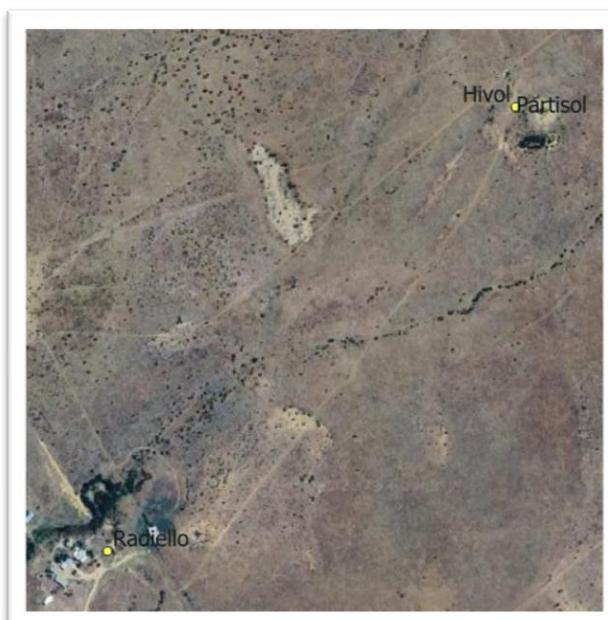
Figure 5 – Partisol, Hivol, Radiello Monitoring Equipment Location

It should be noted that during the month of July the Partisol and HiVol units were relocated slightly farther from the homestead. This action was taken at the request of the tenants. No complaints were received regarding noise from mining operations. The units were moved approximately 1 kilometre (km) from the homestead, and the updated coordinates are provided in the **Table 1**.

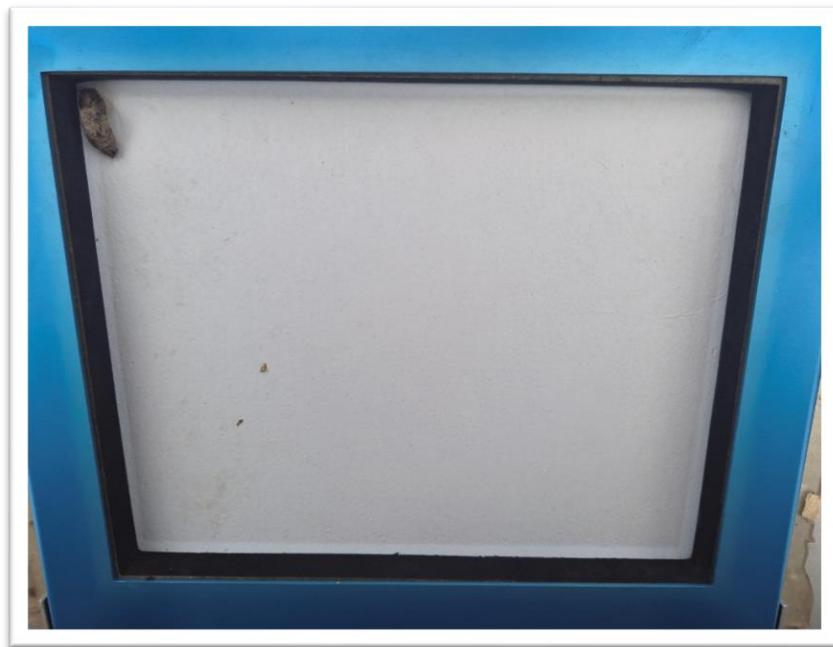
Native wildlife also contributed to sampling difficulties. Frogs frequently inhabited the HIVOL filters contaminating samples (**Figure 8**). Furthermore, a mechanical malfunction occurred, requiring the replacement of the flow sensor.

Figure 8 – Contaminated Hivol Sample

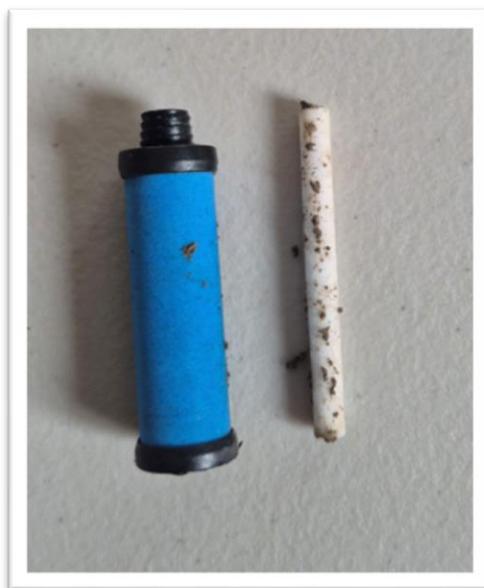
The data capture rate for 2025 was 85.33%. **Table 11** provides details of all data gaps, which have been attributed to factors such as extreme weather conditions. Sun exposure causing the degradation of plastic casings and holders, along with wind gusts knocking the radiello tags off their tags resulting in the tubes falling and compromising sample integrity.

Figure 9 - Radiello Damage
