MULTICOM
RESOURCES

SAINT ELMO PROJECT

ANNUAL NOISE QUALITY MONITORING REPORT

1 January 2025– 31 December 2025

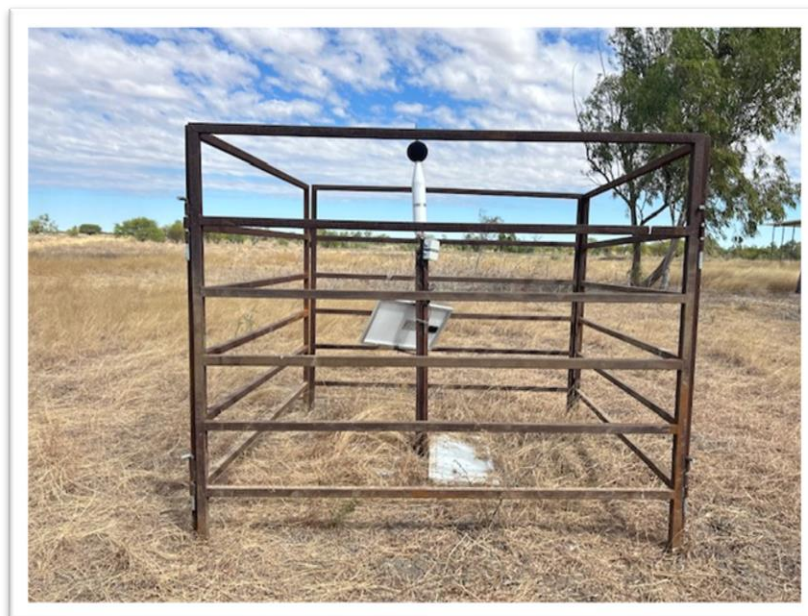
Figure 1 - Noise Monitoring Device

Monitoring is conducted using a Class 1 noise monitoring station with 1/3 octave band analysis, compliant with Australian and New Zealand Standards and holds current National Association of Testing Authorities (NATA) and manufacturer calibration certificates. The monitor performs automatic system checks and can enable calibration factors, periodically verified by a built-in speaker.

The real-time noise monitoring system records one-third octave band noise levels with A-weighting (including LAeq, LA1, LA10, and LA90) over 15-minute intervals. The noise monitoring device is installed in free-field conditions with a microphone height of 1.8 meters (m) above the ground, is connected to mains power and the network via a modem with an embedded SIM card.

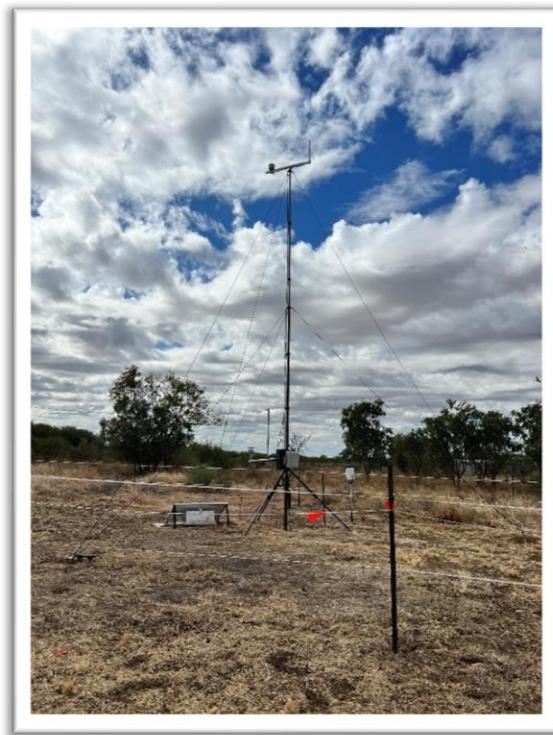
Figure 3 - Saint Elmo Weather Station

Monthly weather data has been included within the noise monitoring results to provide context and help assess how weather conditions may have influenced noise levels during the monitoring period. The weather station is located near the noise monitoring equipment at the homestead and is shown in **Figure 3**.

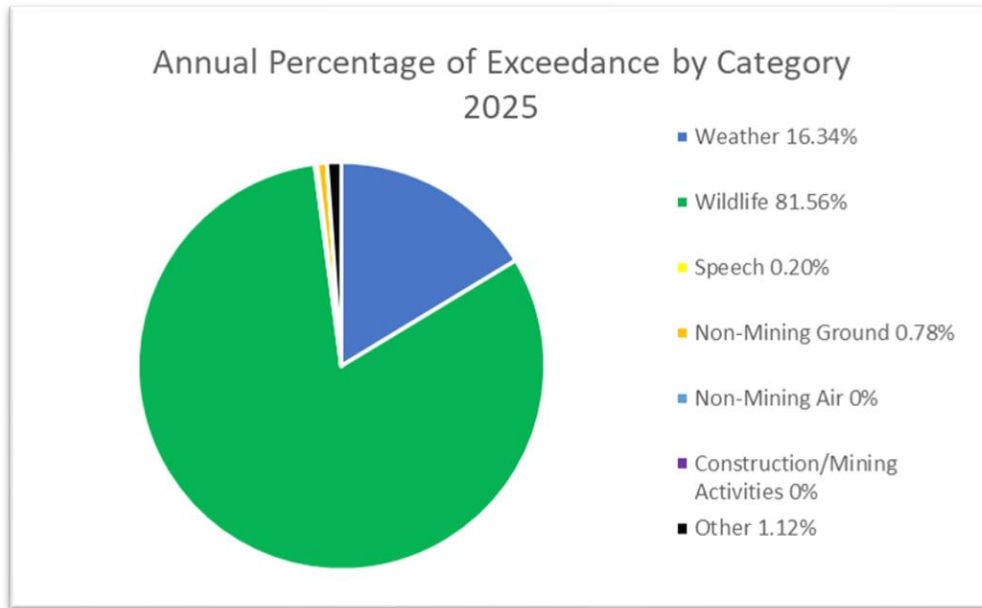
Figure 6 - Percentage of Exceedances by Noise Category

The following data has been presented for the period of 1 January 2025 to 31 December 2025, which details the exceedances percentages by category (**Figure 6**) and for the period (**Figure 7**).
